# Board Level Failure Analysis of Chip Scale Package Drop Test Assemblies

Nicholas Vickers, Kyle Rauen, Andrew Farris, Jianbiao Pan  
Cal Poly State University  
San Luis Obispo, CA 93407

## Abstract

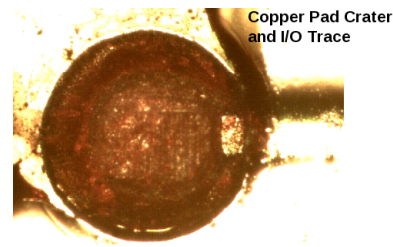
summarizes the percentage of each failure mode on these 60 components analyzed. It shows that pad cratering is the dominant failure mode for these test vehicles in drop impact; 83.3% of the components exhibited pad cratering. Pad cratering is defined as cracking in the thin resin rich region underneath the copper pads and traces as shown in Figure 3. Note that some components had multiple failure modes so that the total percentage shown in Figure 2 is more than 100%.

Figure 3. Copper pad cratering with dyed board fibers, 100X magnification

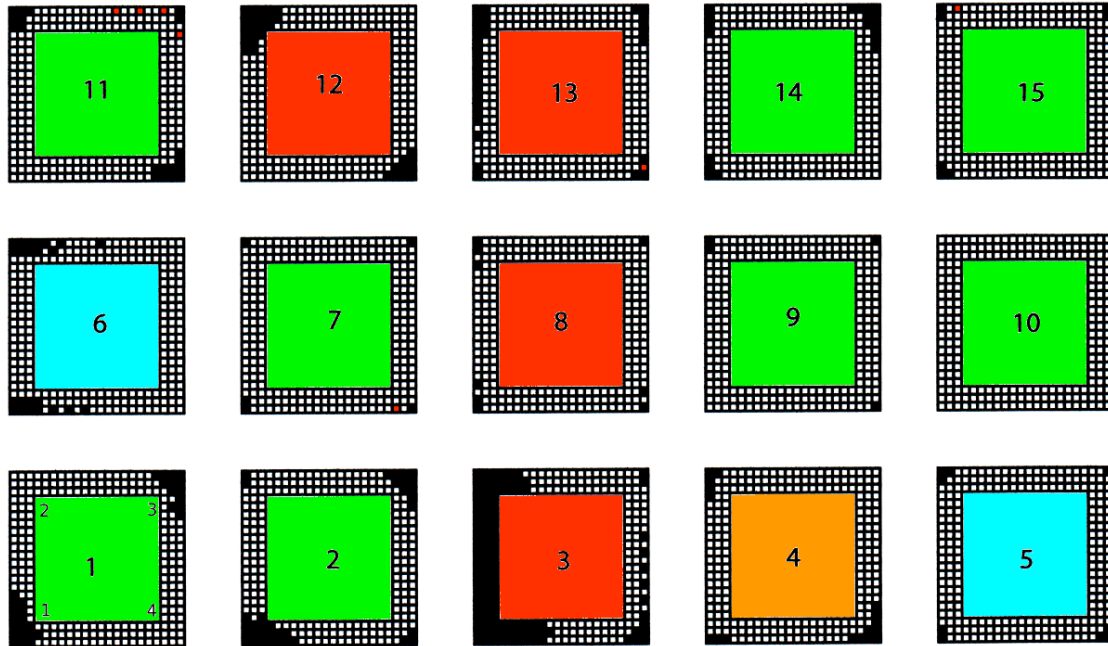
Figures 4 and 5 show boards with no edge-bonding applied to the CSPs, and Figures 6 and 7 show boards with edge-bonding applied [11]. In Figures 5 and 6, pad cratering is shown to occur on nearly every CSP after relatively few drop impacts, and may exist before without electrical failure occurs. In a few cases electrical failure occurred by trace cracking without pad cratering or solder fracture.

It is clear that pad cratering occurred mainly in the corners of the CSPs with the exceptions to components 3, 8, and 13, where it often happened along the edges. The majority of pad cratering occurred on one side of the board (toward component 6), which indicates asymmetric strain distributions along the board. A dynamic failure measurement system was used with a cable attachment near component 6.

Figure 4. Failure mode map for not edge-bonded board after 10 drops at 1500 G.

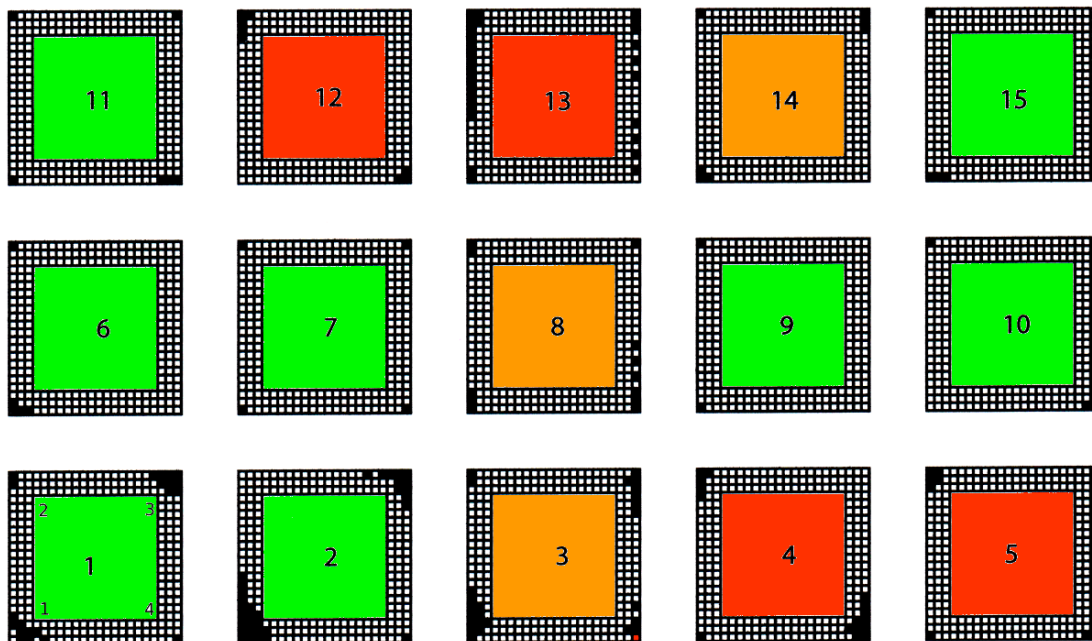
Figure 5. Failure mode map for not edge-bonded board after 14 drops at 1500 G.

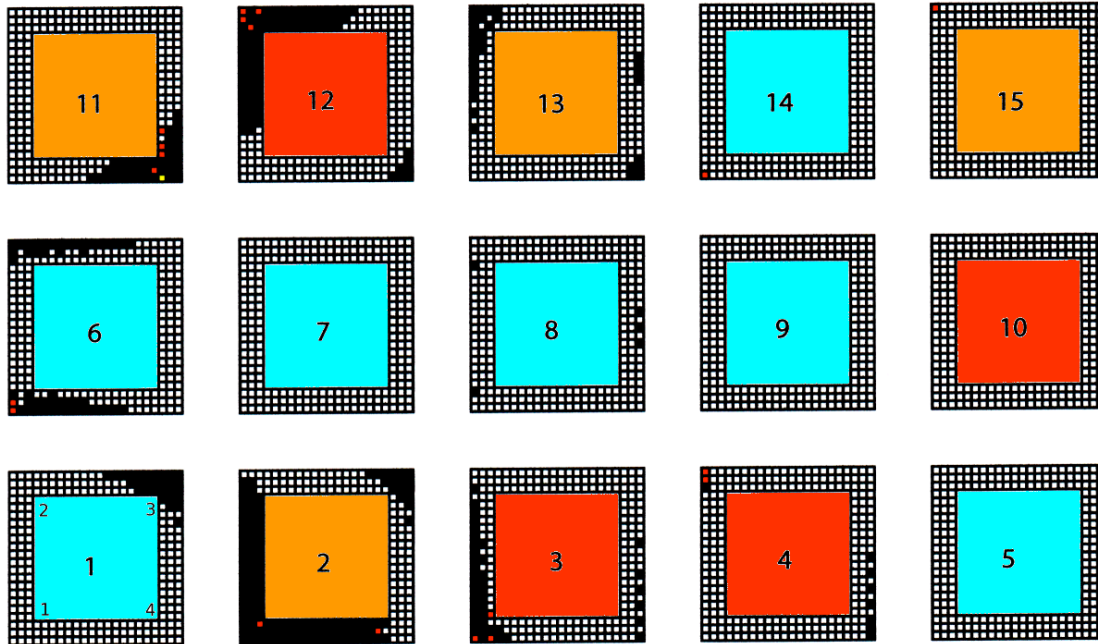
Figure 6. Failure mode map for edge-bonded board after 279 drops at 1500 G.

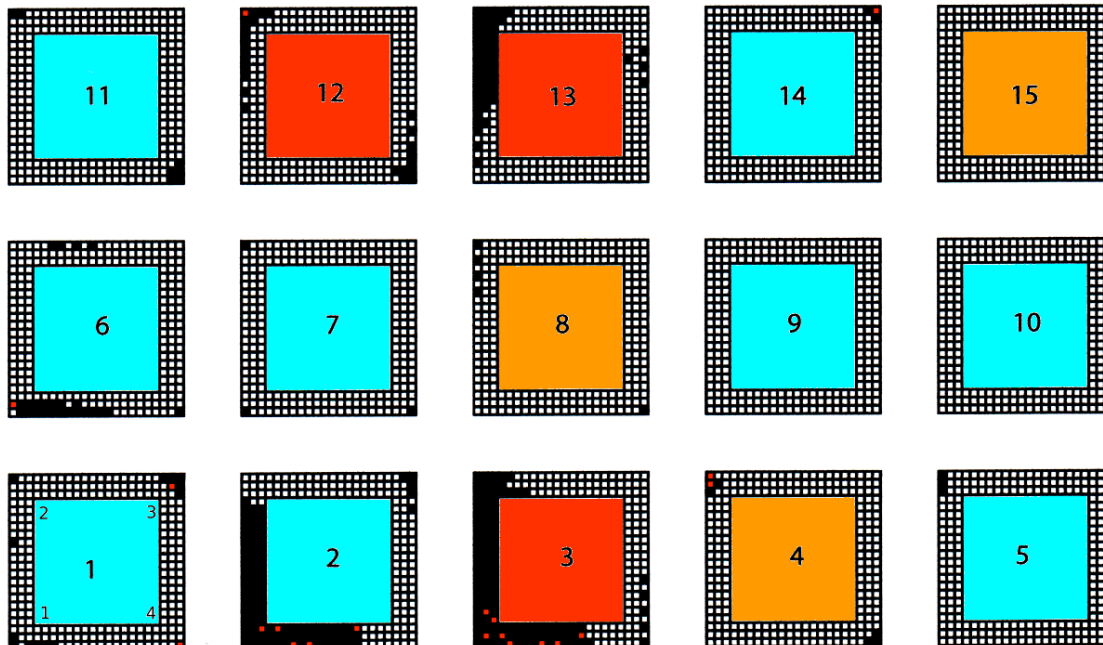
Figure 7. Failure mode map for edge-bonded board after 325 drops at 1500 G.

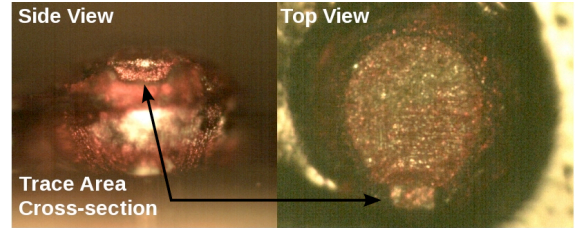
The second most common failure mode is I/O trace fracture as shown in Figure 9. All components that exhibit I/O trace failures also exhibit pad cratering. 72.2% of pad cratered components exhibit I/O trace fracture implying that the two failure modes are coupled. Similarly all daisy chain trace fractured components exhibit pad cratering,

Combining the failure analysis with the reliability study previously reported [11], we see that pad cratering indirectly causes electrical failure. The reasons for this are simple, when the resin cracks under the solder joint, stress is then shifted on to the electrical trace on the PCB. When this occurs the trace can fracture as illustrated in Figure 10. These trace fractures occur both at outside trace connections where the input and output signals occur, and also in traces that connect solder balls within the BGA.

Figure 9. I/O trace cracked away from solder joint, 100X magnification

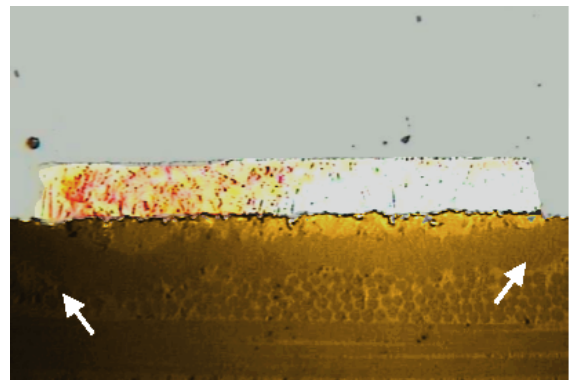
Cross sectioning SEM showed three different failure modes: 1) pad cratering, 2) daisy chain trace fracture, and 3) solder fracture on the board side. Pad cratering as shown in Figure 12 was observed near the corners of the component. Resin cracks that cause pad cratering never penetrated into the weave region and occurred only in the resin rich region above the fiber weave near copper pads and traces. Resin cracks exhibited brittle fracture characteristics. Both daisy chain trace cracking and solder cracking as shown in Figure 13 are less common.

Figure 12. Resin cracks beneath copper pad. Magnification is 500X

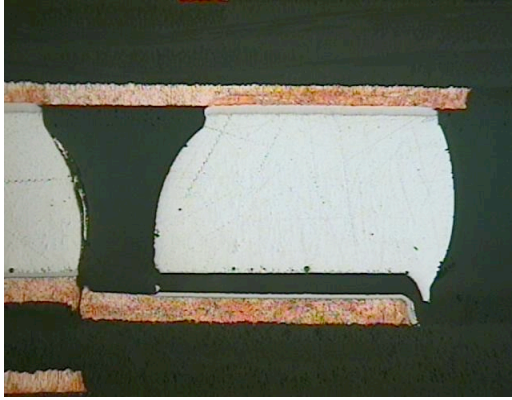
Figure 13. Solder crack near board side IMC shown on the right side of the picture. On the left is evidence of a daisy chain trace fracture on the board side at 100X magnification.

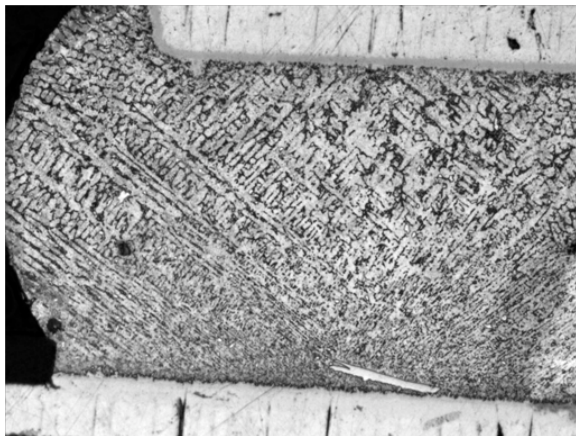
After evaluating the cross-sectioned samples, an investigation of the solder ball microstructure and also the relative strength of the solder material compared to the resin was performed. The resulting microstructure of the solder ball as shown in Figures 14a and 14b shows small dendritic grain growth. The smaller grains strengthen the solder material. Failures are consequently shifted to the weaker material, the resin. Figure 15 shows the microhardness test results. The solder material had an average microhardness of 72 while the resin has a microhardness of 33. The result indicates that the solder is much stronger than the resin. This finding verifies that the resin is the weakest link and suggests that pad cratering should be the most common material failure.

Figure 14a. Image of solder ball microstructure at 200X magnification.

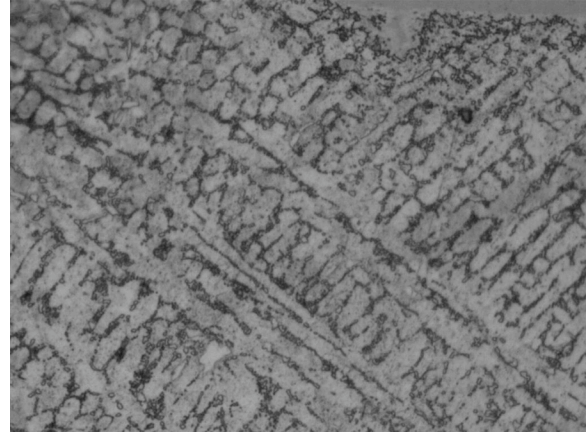
Figure 14b. Image of solder ball microstructure at 500X magnification.
